Frequent procedural errors and structural complications on endodontical treated teeth

Sanziana Adina Scarlatescu¹, Irina Gheorghiu², George Nicola³,
Andrei O. Al Aloul¹, Paula Perlea¹

ABSTRACT

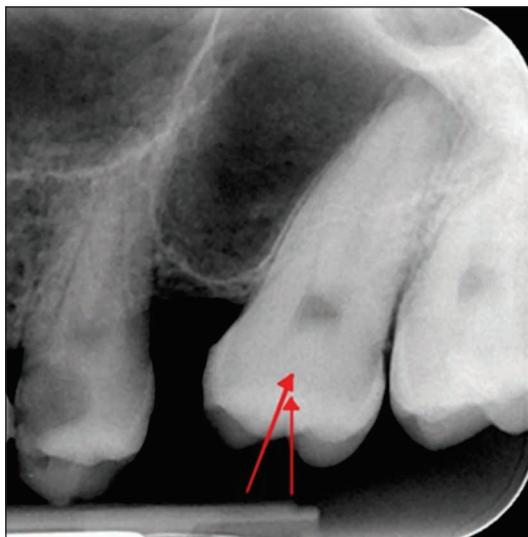
FIGURE 1. Change in the direction of the access burr, after the initial trepanation

bones. In the case of these teeth the access will be done perpendicular to the surface of the tooth, and after the burr has penetrated 2-3 mm inside, it will be reoriented to coincide with the long axis of the root, according to its inclination in the jaw bone (1) (fig. 1).

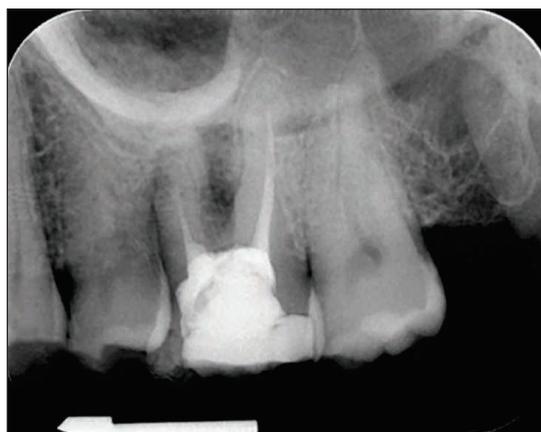
FIGURE 2. Perforation of the pulp floor chamber, lesion developed in the furcation

- the time elapsed since the perforation occurred – the sooner it is treated, the better
- the size of the perforation – perforations less than 3 mm have a better prognosis. The material of choice is MTA
- location – if the perforation involves the floor chamber, an inflammatory lesion may develop in the furcation. That may be prevented by sealing the perforation as soon as possible. In general, good prognoses have those perforations located at the level of the dental furcation, those located in the middle 1/3 and apical 1/3 of the root canal. A worse prognosis have the perforations located in the upper 1/3 of the root (2) (fig. 2).
- lack of bacterial contamination – the isolation with the rubber dam is very important

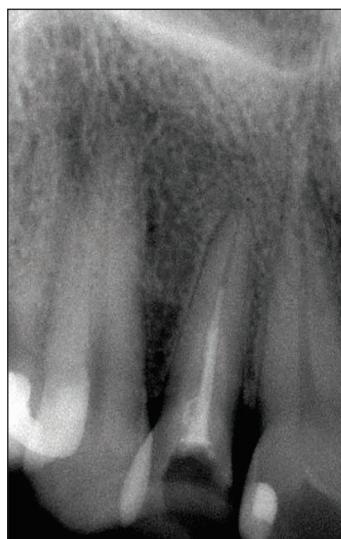
FIGURE 3. Incomplete root canal filling

Canal blockage, decreasing of the working length and incomplete shaping of the endodontic space, is responsible for many failures of endodontic treatment, with flare-ups at different time periods after the end of root canal treatment (fig. 3, 4, 5).

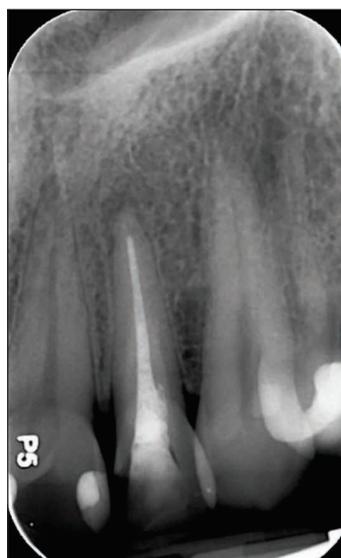
FIGURE 4. Retreatment, apical blockage, flare-up

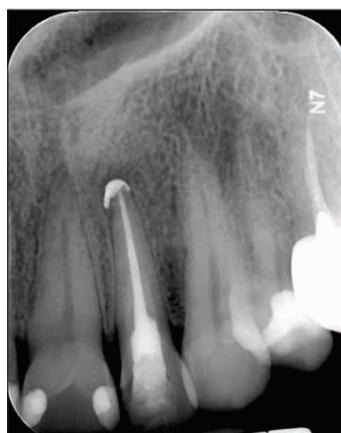
FIGURE 5. Final root canal filling

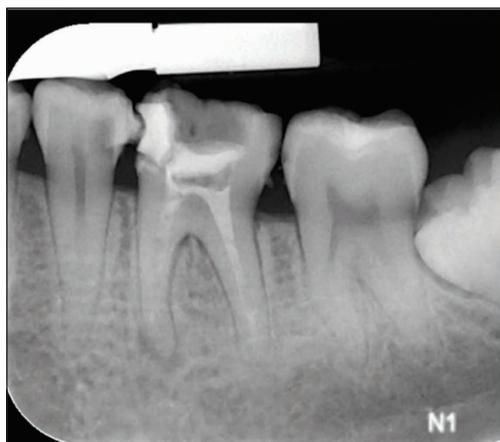
FIGURE 6. Retreatment of 36

The apical transportation/zippering is caused by straightening the apical third of the canal and shifting the canal path to the outer portion of the curve. By widening the apical portion with large rigid files, the destruction of the initial apical constriction occurs and therefore an irregularly shaped enlarged apical third is formed, like a zipper and an apex with a tear drop or elliptical shape, difficult to clean, disinfect and filled (fig. 6, 7).

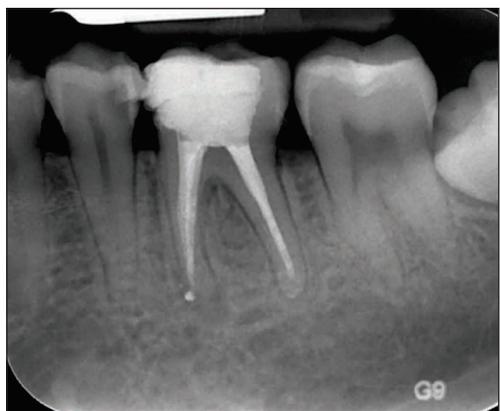
FIGURE 7. Zippering and apical transposition

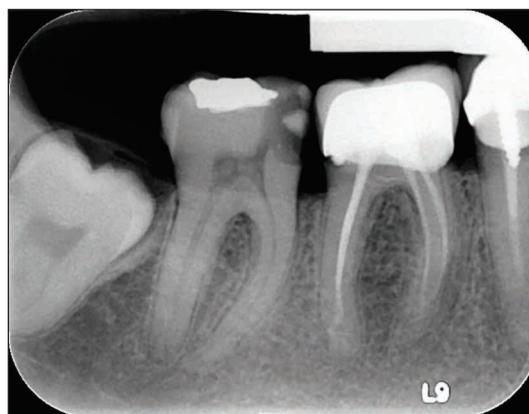
FIGURE 8. Second lower molar, significant curvature of mesial root

The instrumentation of a curved canal must take into account its anatomy, should be done using flexible instruments, avoiding the rigid ones and the preparation should be minimal invasive as to be clinically effective. Otherwise, dangerous thinning of the internal wall may occur which, under the masticatory force, may cause cracks in the root wall, with the appearance of communication between the canal and the periodontium, leading to the failure of the treatment and the loss of the tooth (fig. 8, 9).

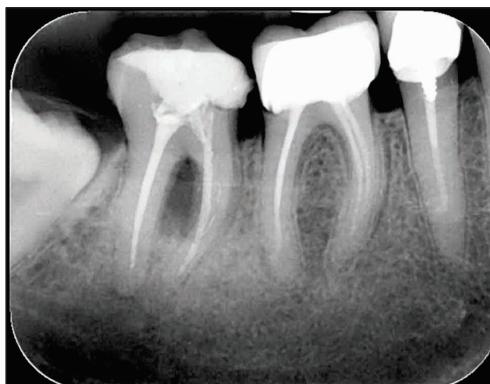
FIGURE 9. *Stripping on mesial root*

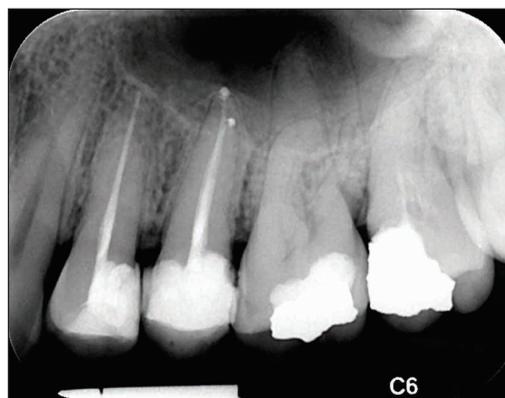
FIGURE 10. *Apical puffs*

Overfilling with small amount of sealer (puffs) is in general well tolerated by the body. It is attesting the filling of the entire root canal and in particular the root canal constriction – apical foramen (fig. 10). It is considered that overfilling up to 2 mm with paste/sealer or gutta-percha cone, without being considered a normality, can be more quickly integrated by the body (8), but massive overextensions should always be avoided by accurately determining the working length, the exact preparation of the root canals, the suitable choice of a master cone and a proper root canal filling technique, avoiding the introduction of large quantity of sealing cement (9) (fig. 11). Overextended fillings endanger relations with neighboring anatomical structures and can only be removed surgically.

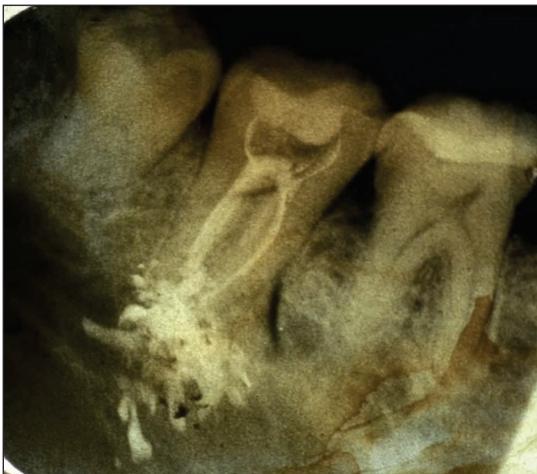
FIGURE 11. Large overfilling with sealer

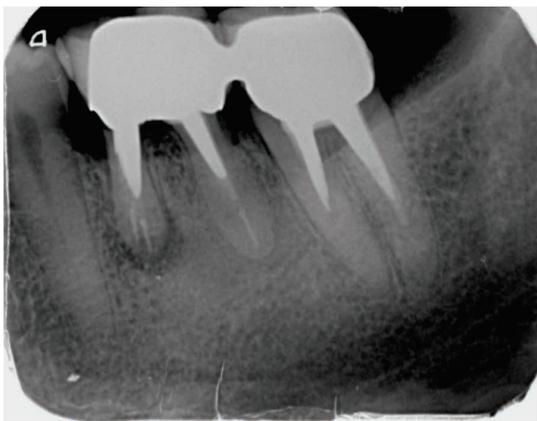
FIGURE 12. Extensive fracture between the mesial and distal roots

Complete fracture of the tooth, affecting the root canals, usually vertical root fractures (VRF). In these cases, the tooth may not be restorable and it needs to be extracted (fig.12, 13).

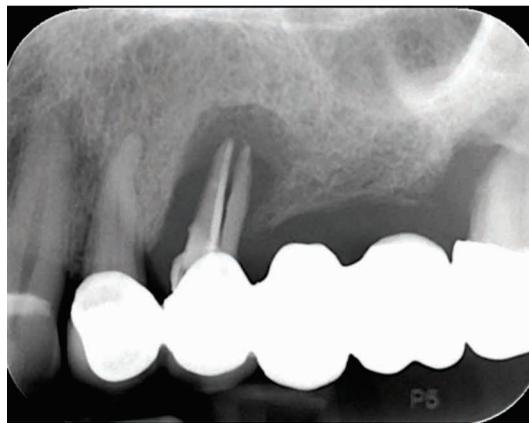
FIGURE 13. Vertical root fracture upper second premolar
