Orthodontic movement of teeth with horizontal root fracture: A case report

Nader Giacaman¹, Mohammed Jaradat²

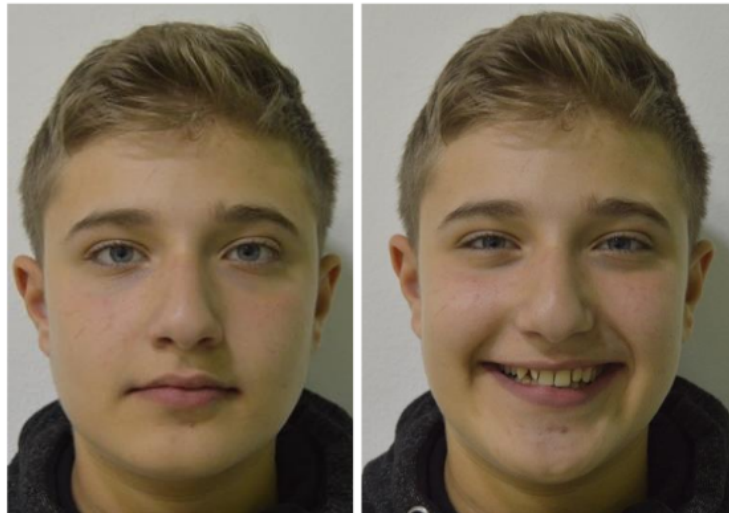
Figure 1: Pre-treatment extraoral and intraoral photographs (taken using Nikon digital SLR Camera D3200)

A 16 years-old male patient was referred to the orthodontic clinic for malocclusion. The patient was medically fit and healthy. His dental history revealed a previous trauma to his anterior teeth five years ago. He complained of irregular front teeth. Clinical and radiographic examinations were performed. The extraoral examination revealed the presence of a symmetric face, an average smile line and reduced lower anterior facial height. The intraoral examination revealed the presence of class II division 2 incisor relationship on skeletal base class II complicated by crowding in both dental arches and an impacted lower right 2nd premolar (Figure 1). The radiographic examination revealed the presence of a horizontal root fracture (in the middle third) of the upper right central incisor (Figure 2). Upon examination, all maxillary anterior teeth responded to electric pulp-testing.

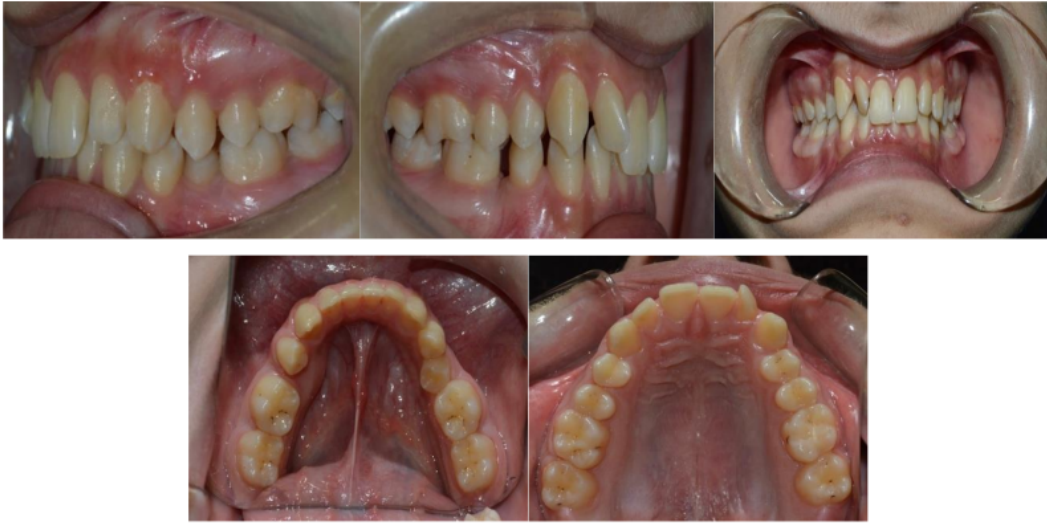
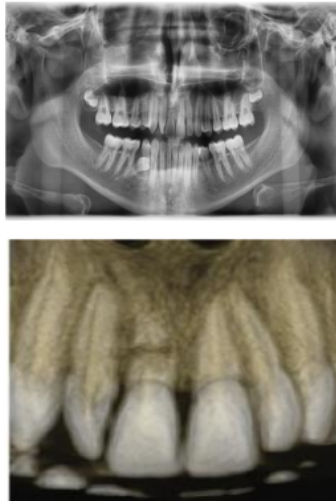
14
figure 2: Pre-treatment panoramic & CBCT X-rays

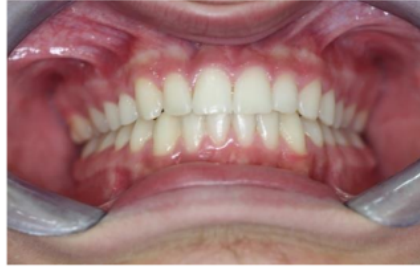
Figure 3: Post-operative frontal view for the occlusion (taken using Nikon digital SLR Camera D3200)

At the end of the 20 months of active orthodontic treatment, the maxillary and mandibular teeth (including the impacted mandibular second premolar) were aligned. The incisors, canines, and molars were in a class I relationship with an average overbite (Figure 3). The post-operative panoramic x-ray revealed the separation of the apical and coronal root segments (Figure 4) of the maxillary right central incisor. The vitality test using ethyl chloride also revealed the presence of a vital pulp. Table 1 shows the flowchart for the orthodontic treatment.

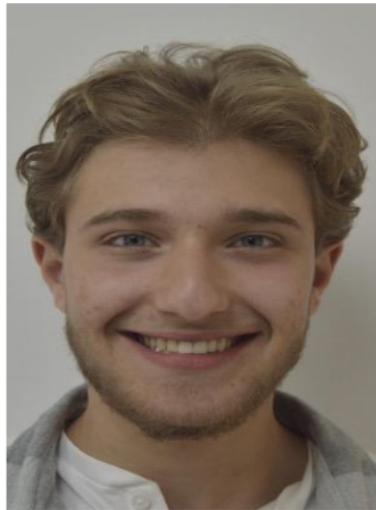
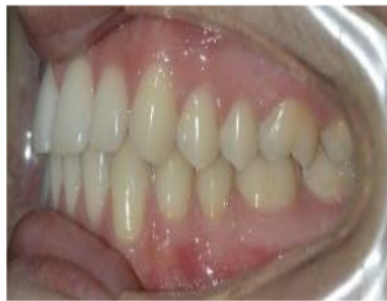
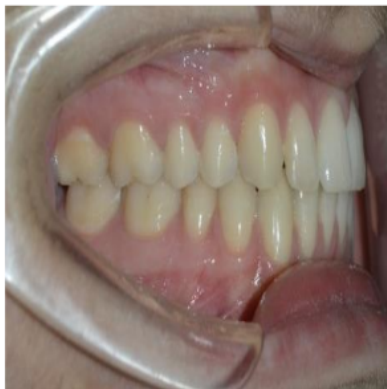
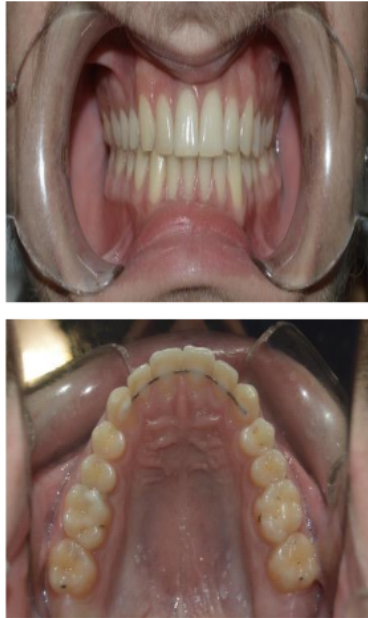
Figure5: Follow-up extraoral and intraoral photographs (taken using Nikon digital SLR Camera D3200)

At the end of the active treatment, the appliance was de-bonded and the patient was given two types of retainers in each arch; a bonded fixed retainer and a removable Essex retainer. Although teeth with horizontal root fracture have a higher potential of maintaining a vital dental pulp than luxated teeth without fracture, pulp necrosis can still occur in 20 to 44% of the cases. For teeth with retained vitality, the reason may be attributed to the force that occurs during the fracture being transmitted to the apical region of the tooth, thus leading to decreased force and the likelihood of obtaining revascularization in the fracture line. Furthermore, it is believed that the fractured area provides an avenue of escape for fluid pressure from edema, therefore allowing collateral circulation from the periodontal ligament to assist in maintaining the vitality of the traumatized pulp [9]. In our case, the patient was followed up for 18 months and the subsequent clinical and radiographic examinations were found to be satisfactory (figures 5 &6).

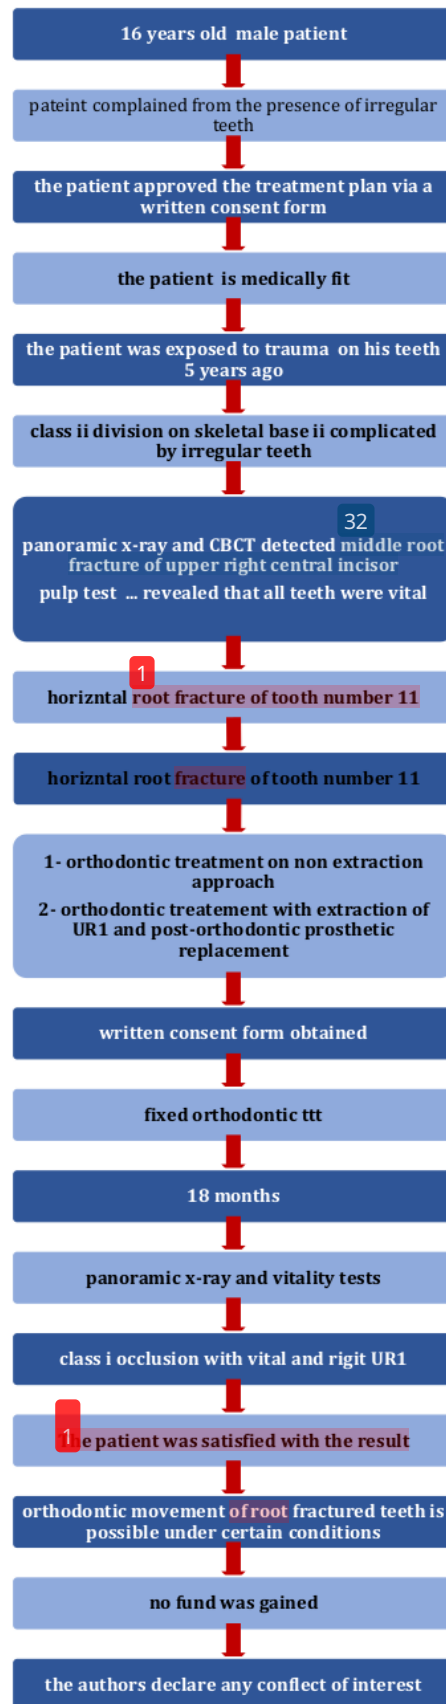
Table # 1: Flow chart of the orthodontic treatment
